CASE STUDY

Adhesion Problems in Polymer Laminate Films

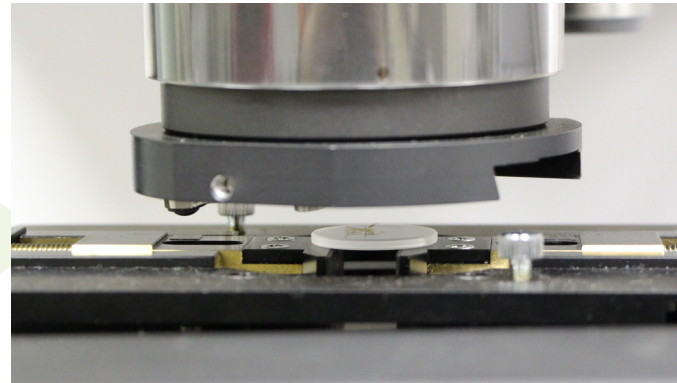
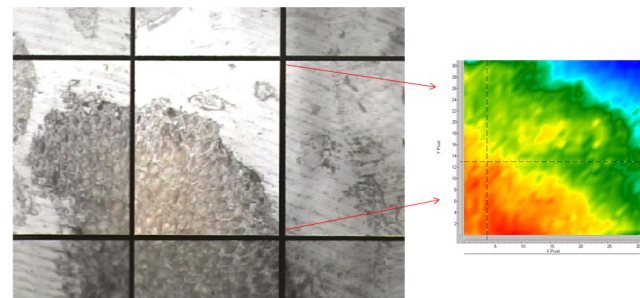
- **Axio Imaging** – preliminary assessment of the samples using high-definition images of the cross-sections of the samples
- **FTIR Spectroscopic Chemical Imaging Test** – examined multi-layer laminates using IR imaging microscopy to determine the spatial distribution of the contaminant.
- **Hyperspectral Imaging Analysis** – hyperspectral images were generated using a spectral peak that was unique to the contaminant, allowing us to determine the location and identity of the contaminants.

Based on the IR imaging results, FibreCITY determined that the adhesive glue had overflowed onto the packaging material causing the adhesive problem. Using these findings, the client was able to fix the problem and continue production with minimal disruption.
