# CASE STUDY

## Investigation of the Fibre/Resin Interface of an Epoxy Prepreg

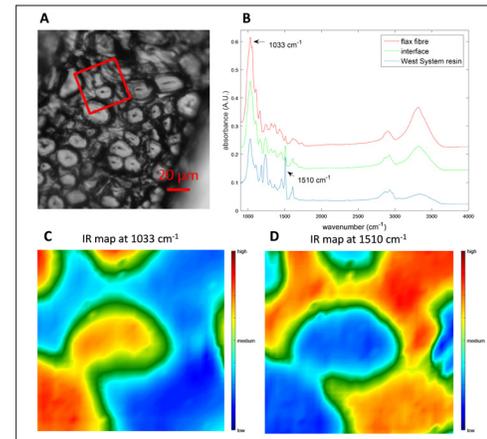
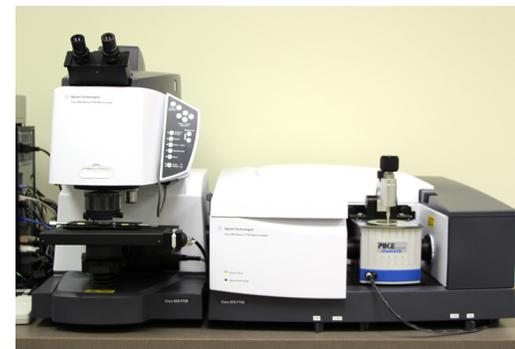
Micro-voids could not be found in the samples; however, the results from the in-situ FTIR showed a chemical gradient was present between the fibre surface and the bulk resin. This gradient was characterized by a reduced amount of cross-linking as the resin approached the fibre surface. It was determined that the fibre sizing was likely interfering with the amount of cross-linking needed in the resin to achieve the desired performance.
